**Flood Control Project Maintenance
Levee Inspections****LMA District Cover Sheet****Spring 2015 Levee Inspection Results****Reclamation District No. 0017 Mossdale**

Spring 2015 Levee Inspection Results

Reclamation District No. 0017 Mossdale

Levee Inspection Report By Mile - Spring 2015

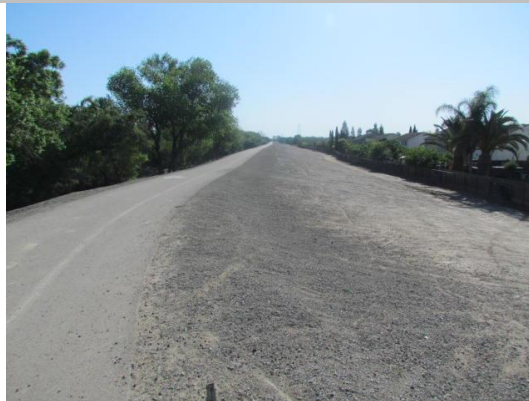
Photo 1 of 1 : SP_2015_RD0017_303_9_20150416_00001.jpg

LM Start	0.00	Rating **	M	Issue No.	9		
LM End	1.76	Issue Type +	Ma	Location *	LS		
Category	Earthen Levee			GPS Latitude/Longitude			
				Start		End	
Item	Vegetation				o		o
					o		o
DWR ID	DWR_RD0017_01_s_2015_9						
Action/Comments							
Control annual grass and weeds on the levee slopes and easements.

Looking south at typical view of landward slope.

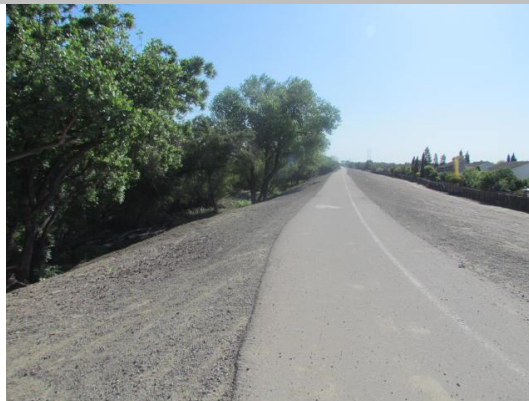
Photo 1 of 1 : SP_2015_RD0017_303_10_20150416_00002.jpg

LM Start	0.00	Rating **	M	Issue No.	10
LM End	1.76	Issue Type +	Ma	Location *	WS
Category	Earthen Levee			GPS Latitude/Longitude	
				Start	End
Item	Vegetation				o
					o
DWR ID	DWR_RD0017_01_s_2015_10				
Action/Comments					
Control annual grass and weeds on the levee slopes and easements.

Looking south at typical view of waterward slope.

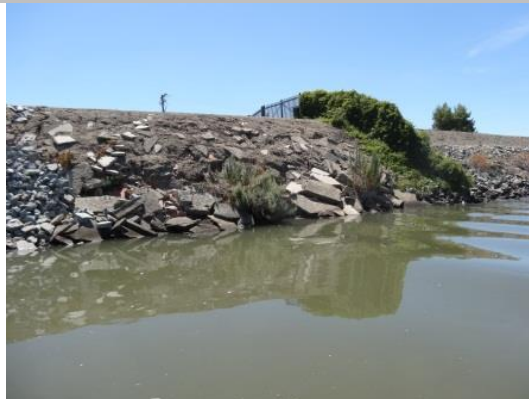
Photo 1 of 1 : SP_2015_RD0017_304_6_20150309_00004.jpg

LM Start	1.08	Rating **	U	Issue No.	6
LM End	1.08	Issue Type +	Ma	Location *	WS
Category	Supplemental			GPS Latitude/Longitude	
				Start	End
Item	DWR Erosion Survey			37.902530 °	37.902530 °
				-121.325690 °	-121.325690 °
DWR ID	DWR_RD0017_02_s _ 2015_6				
Action/Comments					
Inspector Comments: 6/19/2014: No significant change observed. 08/13/2013: No significant change at this site. 08/07/2012: The erosion is nearly vertical, and has developed upward to halfway of the levee slope. The protecting concrete blocks have been washed away. Animal activities are visible. [2014 Site ID:RD0017U02RM44.32] Site has been corrected.

Front view of the erosion site. Note the concrete blocks and vegetation.

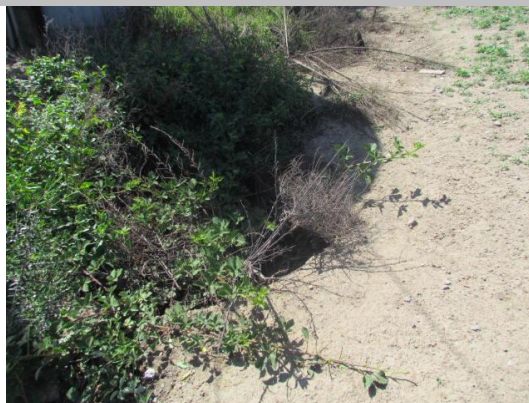
Photo 1 of 3 : SP_2015_RD0017_304_78_20150416_00020.jpg

LM Start	1.16	Rating **	U	Issue No.	78
LM End	1.16	Issue Type +	Ma	Location *	LS
Category	Earthen Levee			GPS Latitude/Longitude	
				Start	End
Item	Erosion / Bank Caving			37.901318 °	37.901318 °
				-121.325522 °	-121.325522 °
DWR ID	DWR_RD0017_02_s _ 2015_78				
Action/Comments					
Schedule repair of erosion site prior to the next inspection. Inspector Comments: Sink hole (4' x 18" x 5')next to pipe.

Looking north at sink hole on landward toe next to irrigation pipe.

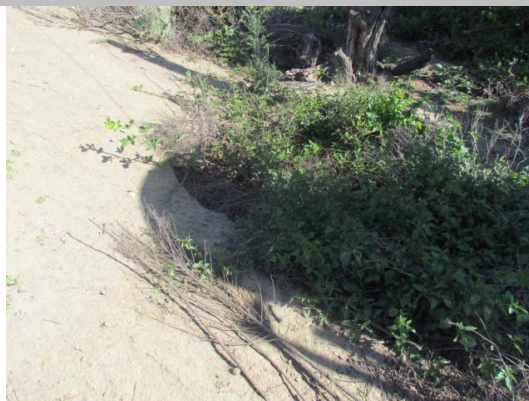
Photo 2 of 3 : SP_2015_RD0017_304_78_20150416_00019.jpg

LM Start	1.16	Rating **	U	Issue No.	78 (cont)
LM End	1.16	Issue Type +	Ma	Location *	LS

Looking south at sink hole at landward toe next to irrigation ppe.

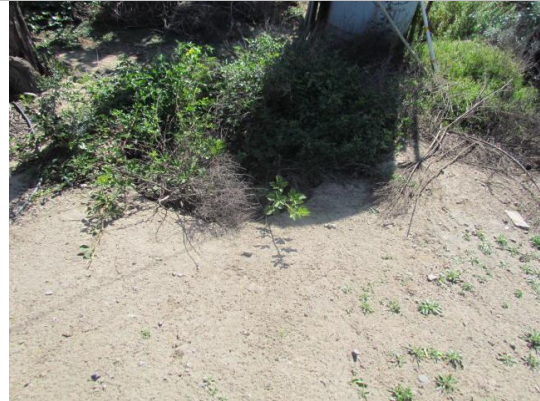
Photo 3 of 3 : SP_2015_RD0017_304_78_20150416_00021.jpg

LM Start	1.16	Rating **	U	Issue No.	78 (cont)
LM End	1.16	Issue Type +	Ma	Location *	LS
Category	Earthen Levee			GPS Latitude/Longitude	
				Start	End
Item	Erosion / Bank Caving			37.901318 °	37.901318 °
				-121.325522 °	-121.325522 °
DWR ID	DWR_RD0017_02_s_2015_78				
Action/Comments					
Schedule repair of erosion site prior to the next inspection.					
Inspector Comments: Sink hole (4' x 18" x 5')next to pipe.

Looking west at sink hole on landward toe next to irrigation pipe.

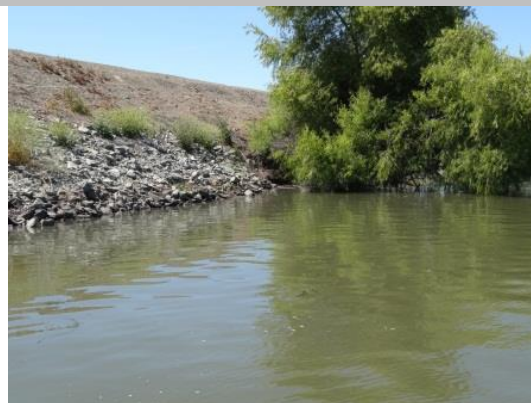
Photo 1 of 1 : SP_2015_RD0017_304_14_20150309_00010.jpg

Action/Comments					
Inspector Comments: 06/19/2014: The erosion has been repaired. A minor erosion is still visible near the tree. 08/13/2013: A mid-size tree is present immediately upstream of the erosion, which could block the view of the site. Some debris is visible. [2014 Site ID:RD0017U02RM44.52]

View from downstream.

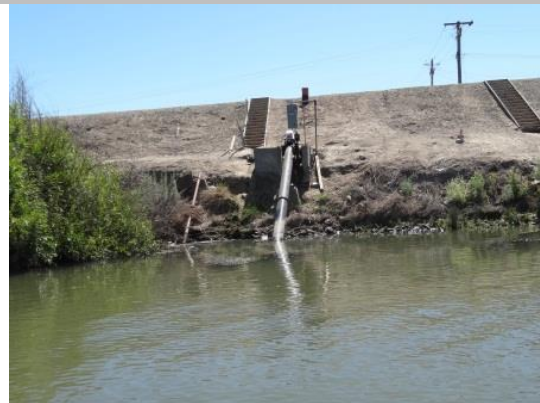
Photo 1 of 1 : SP_2015_RD0017_304_92_20150309_00015.jpg

Action/Comments					
Inspector Comments: 6/19/2014: The erosion was probably caused by the irrigation pipe found at the site. [2014 Site ID:RD0017U02RM45.94]

Close view of the erosion site.

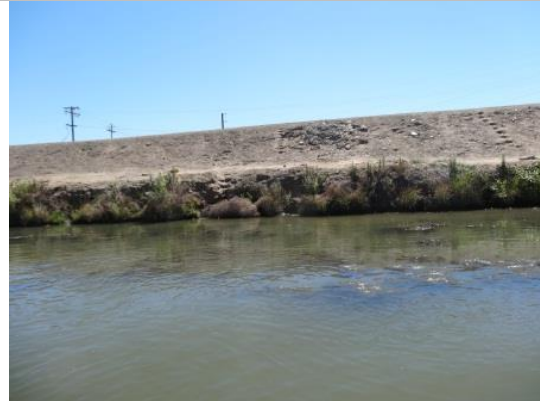
Photo 1 of 1 : SP_2015_RD0017_304_93_20150309_00016.jpg

LM Start	2.68	Rating **	M	Issue No.	93
LM End	2.68	Issue Type +	Ma	Location *	WS
Category	Supplemental			GPS Latitude/Longitude	
				Start	End
Item	DWR Erosion Survey			37.880710 °	37.880710 °
				-121.332200 °	-121.332200 °
DWR ID	DWR_RD0017_02_s_2015_93				
Action/Comments					
Inspector Comments: 6/19/2014: The erosion is in the river bank which has an estimated 10-ft wide berm. [2014 Site ID:RD0017U02RM45.95]

Front view of the erosion along the water edge. Note the vegetation at the erosion site.

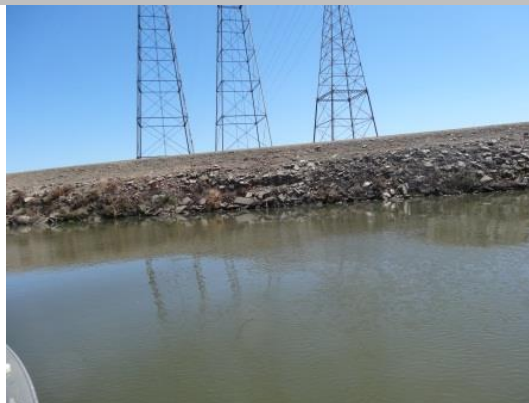
Photo 1 of 1 : SP_2015_RD0017_304_95_20150309_00017.jpg

LM Start	2.82	Rating **	M	Issue No.	95
LM End	2.82	Issue Type +	Ma	Location *	WS
Category	Supplemental			GPS Latitude/Longitude	
				Start	End
Item	DWR Erosion Survey			37.878660 °	37.878660 °
				-121.332400 °	-121.332400 °
DWR ID	DWR_RD0017_02_s_2015_95				
Action/Comments					
Inspector Comments: 06/19/2014: A pocket erosion was found during the boat survey. [2014 Site ID:RD0017U02RM46.1]

Front view of the erosion.

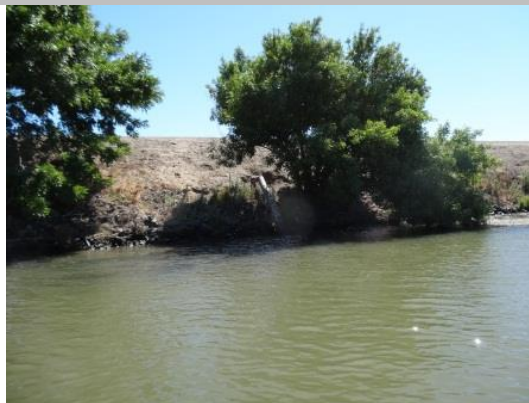
Photo 1 of 1 : SP_2015_RD0017_304_96_20150309_00018.jpg

LM Start	3.63	Rating **	M	Issue No.	96
LM End	3.63	Issue Type +	Ma	Location *	WS
Category	Supplemental			GPS Latitude/Longitude	
				Start	End
Item	DWR Erosion Survey			37.868500 °	37.868500 °
				-121.327670 °	-121.327670 °
DWR ID	DWR_RD0017_02_s_2015_96				
Action/Comments					
Inspector Comments: 06/19/2014: The erosion is near a large tree and probably has been caused by the irrigation pipe on the site. [2014 Site ID:RD0017U02RM46.89]

Front view of the erosion. Note the tree and the irrigation pipe.

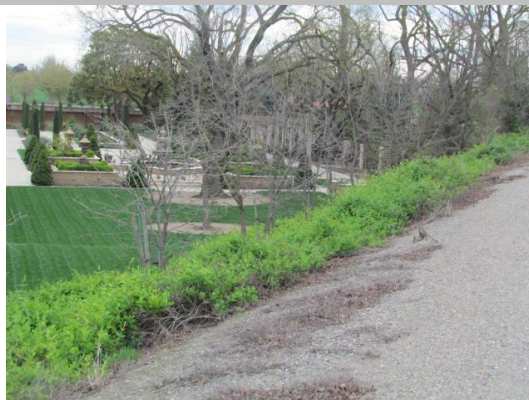
Photo 1 of 3 : SP_2015_RD0017_304_48_20150309_00012.jpg

LM Start	4.19	Rating **	A/W	Issue No.	48
LM End	4.22	Issue Type +	En	Location *	LS
Category	Earthen Levee			GPS Latitude/Longitude	
				Start	End
Item	Vegetation			37.863819 °	37.863601 °
				-121.320784 °	-121.320299 °
DWR ID	DWR_RD0017_02_s_ 2012_48				
Action/Comments					
Landscaping

Looking southeast at dense ground cover on landside slope. (Spring 2013)

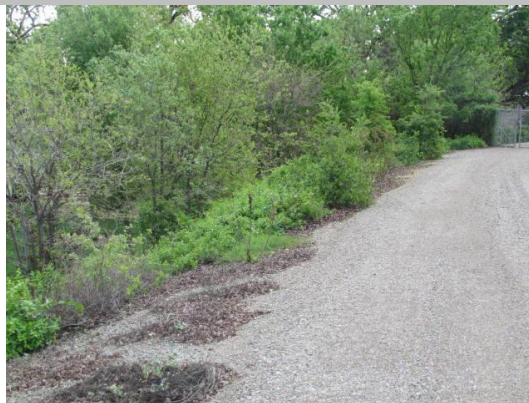
Photo 2 of 3 : SP_2015_RD0017_304_48_20150309_00013.jpg

LM Start	4.19	Rating **	A/W	Issue No.	48 (cont)
LM End	4.22	Issue Type +	En	Location *	LS
Category	Earthen Levee			GPS Latitude/Longitude	
				Start	End
Item	Vegetation			37.863819 °	37.863601 °
				-121.320784 °	-121.320299 °
DWR ID	DWR_RD0017_02_s_2012_48				
Action/Comments					
Landscaping

Looking southeast at overgrown landscaping on landside slope. (Spring 2014)

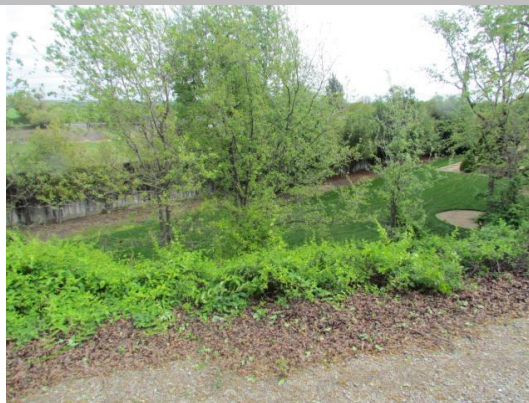
Photo 3 of 3 : SP_2015_RD0017_304_48_20150309_00014.jpg

LM Start	4.19	Rating **	A/W	Issue No.	48 (cont)
LM End	4.22	Issue Type +	En	Location *	LS

Looking east at overgrown landscaping on landside slope. (Spring 2014)

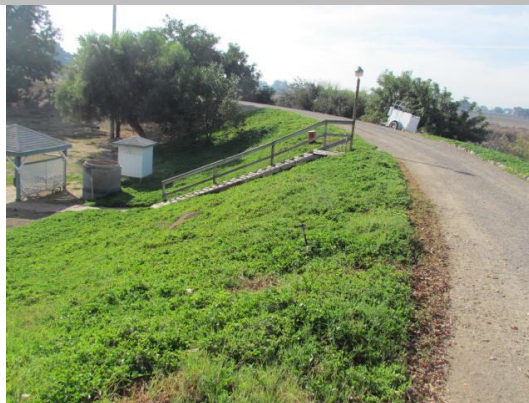
Photo 1 of 3 : SP_2015_RD0017_304_1_20150309_00001.jpg

LM Start	4.37	Rating **	M	Issue No.	1 (cont)
LM End	4.39	Issue Type +	En	Location *	LS

Looking southeast at ground cover on landside slope.

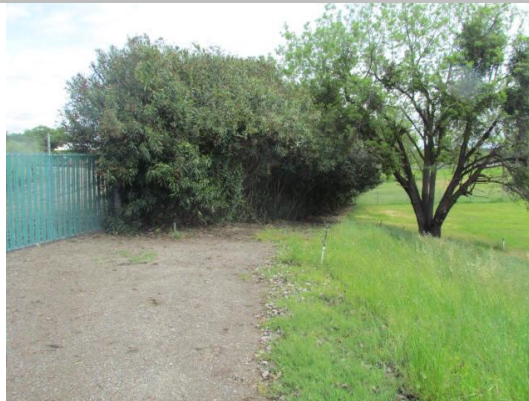
Photo 2 of 3 : SP_2015_RD0017_304_1_20150309_00002.jpg

Looking south at overgrown oleanders on landside shoulder. (Spring 2014)

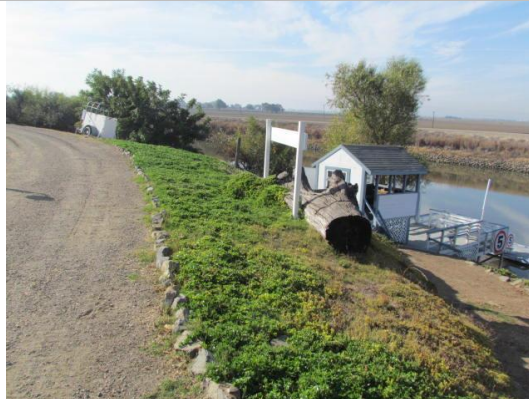
Photo 3 of 3 : SP_2015_RD0017_304_1_20150309_00003.jpg

Looking southwest at landscaping and boat dock on waterside slope and channel.

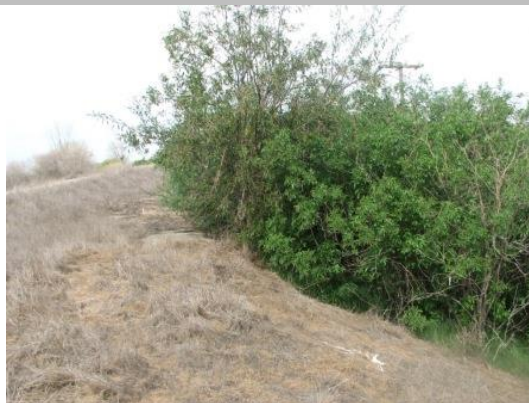
Photo 1 of 1 : SP_2015_RD0017_304_25_20150309_00011.jpg

LM Start	7.58	Rating **	M	Issue No.	25
LM End	7.60	Issue Type +	Ma	Location *	LS
Category	Earthen Levee			GPS Latitude/Longitude	
				Start	End
Item	Vegetation			37.828095 °	37.827920 °
				-121.309945 °	-121.309847 °
DWR ID	DWR_RD0017_02_s_2012_25				
Action/Comments					
Elderberries are blocking visibility and flood fight capability.

Elderberry blocking view of landside slope and toe.

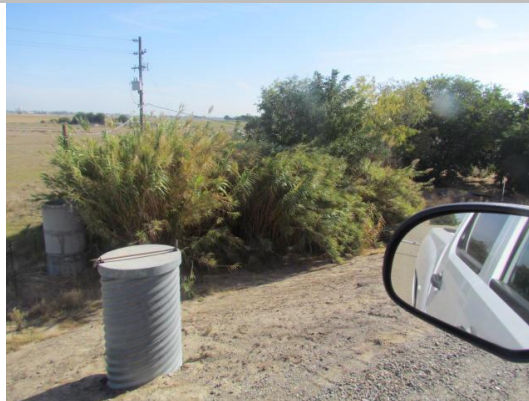
Photo 1 of 1 : SP_2015_RD0017_304_9_20150309_00005.jpg

LM Start	9.28	Rating **	M	Issue No.	9
LM End	9.28	Issue Type +	Ma	Location *	LS
Category	Earthen Levee			GPS Latitude/Longitude	
				Start	End
Item	Vegetation			37.815243 °	37.815243 °
				-121.317470 °	-121.317470 °
DWR ID	DWR_RD0017_02_s _ 2012_9				
Action/Comments					
Elderberries are blocking visibility and flood fight capability.

Looking east at bamboo at landward toe.
